Apartment Balcony Sliding Doors

Wind Investigation

Altair Apartments

Timber & Glass Joinery P/L

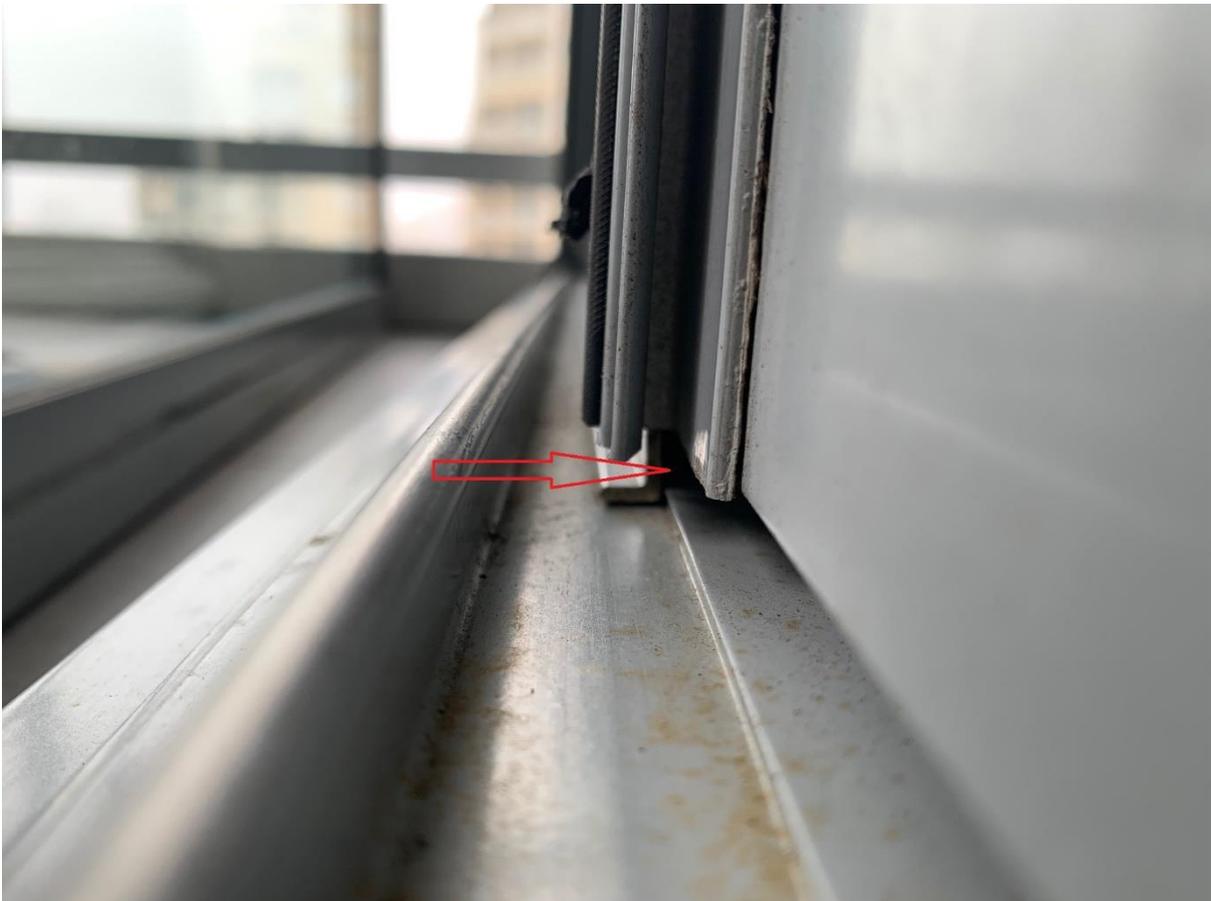
Starting at the outside bottom of the door you will notice the gap between the two interlocking stiles. This gap has the potential to allow air to flow through. This gap is necessary to allow the door to slide on the Door Sill and achieve its purpose. See below.

The three areas mentioned above are at each point the junction of six pieces of extrusion. Two vertical stiles, two horizontal rails, a door sill and a door threshold. It is not possible to achieve an air tight seal with so many moving parts at these junctions. Multiply this by the number of junctions points on all the doors in an apartment and this shows the amount of air gaps with in the door system.

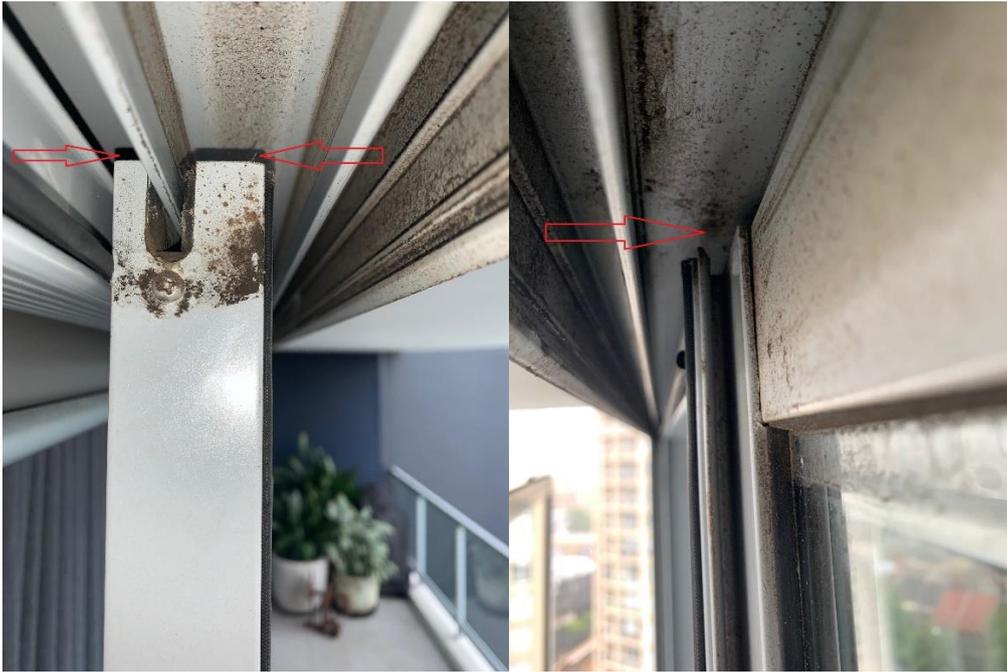
At the top of the door outside, you will notice a gap at the top of the door. This gap also has the potential to allow air to flow through. This gap is necessary to allow the door to slide on the Door Sill and achieve its purpose. See below.

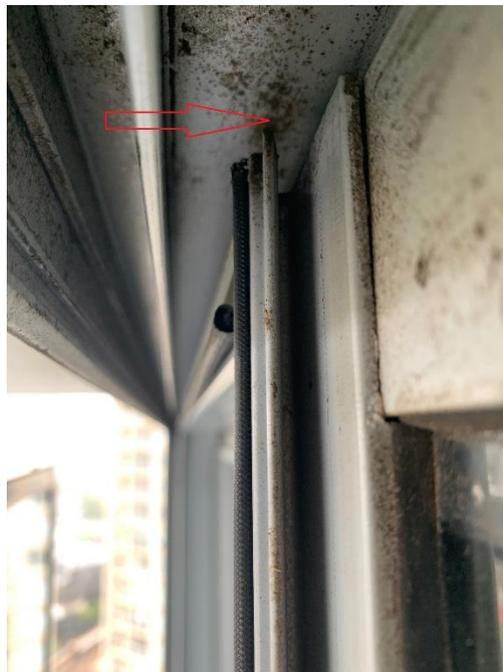
At the top interlock junction (where the two vertical stiles engage) you will notice a cut out. This space is required for the sliding sash to be adjusted for smooth operation and also allows for some movement of the Top sill. See below.

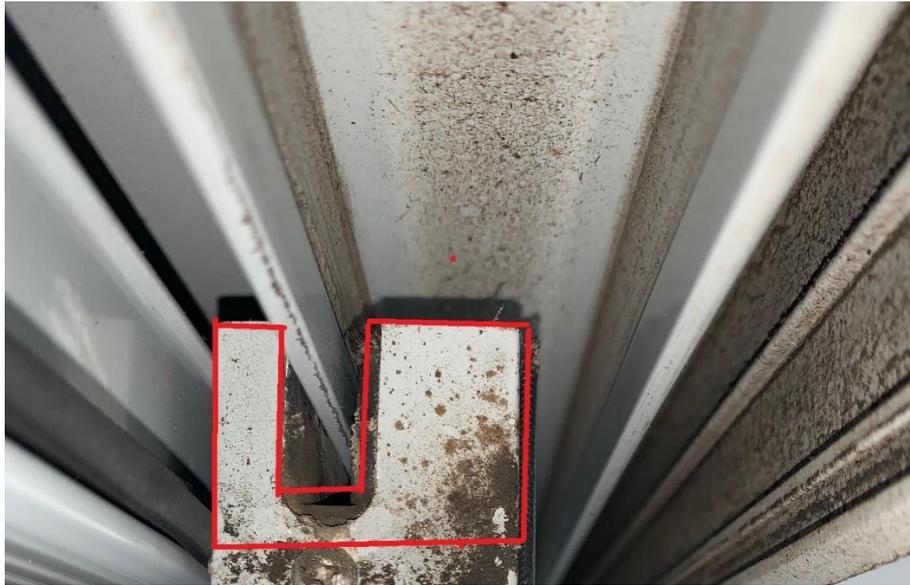
There is no workable solution to sealing all the air gaps in the doors.

An experiential avenue, meaning that there is no guarantee that any reduction what so ever, in wind flow through will be achieved, is to possibly place a rubber stop of some description on the ends of the doors. See below.

Noting again that this action is purely experimental and come with no guarantees.
